# **Lessons Learnt from Fukushima Daini NPP (2F) and Status of Fukushima Daiichi NPP (1F)**

**June 4, 2012**

**Fukushima Daini NPP**

**TOKYO ELECTRIC POWER COMPANY**

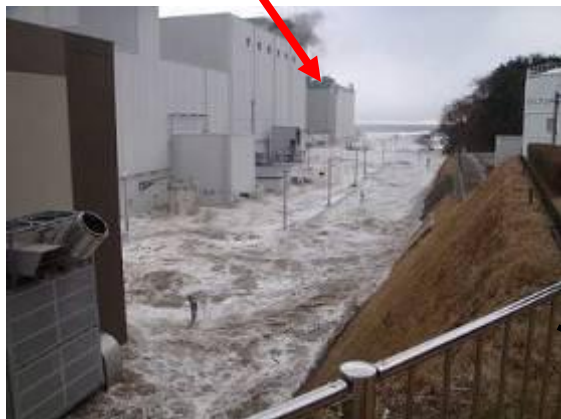
Unit 1

- R/B: Flooding through ventilation louvers  
→ Damage in emergency power system
- Hx/B: Damage of watertight hatches  
→ Damage in reactor cooling system

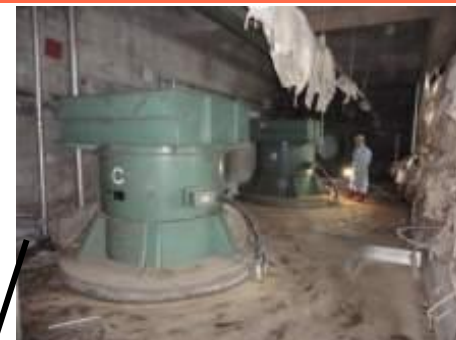
EDG air blower

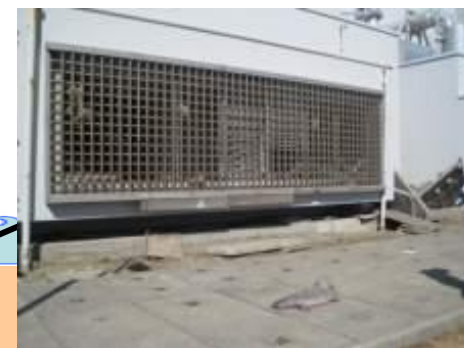
Ventilation louver

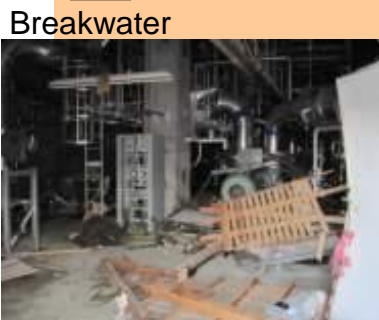
Cooling pump

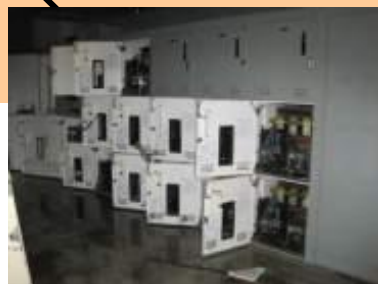
Power cubicles

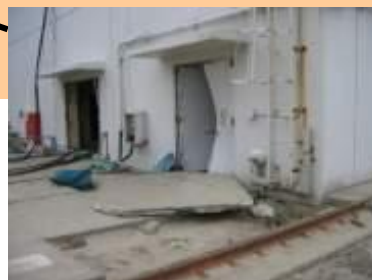
Equipment hatches

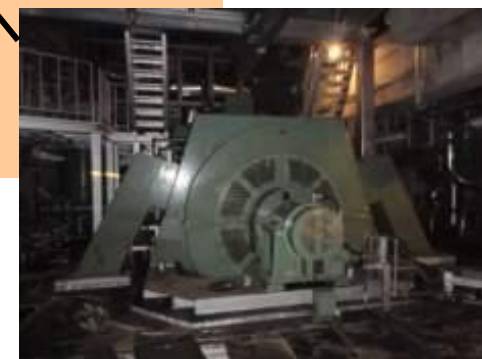
Emergency Diesel Generator (EDG)

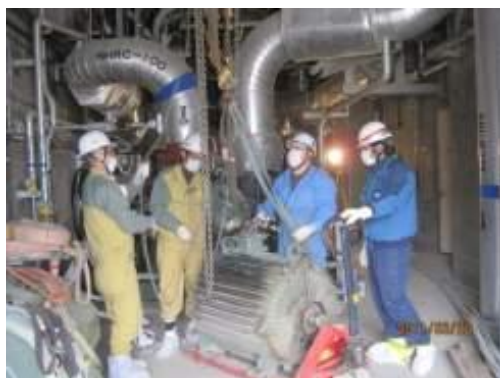
Motor replacement

- RHR cooling systems (RHRC, RHRS, EECW) were inspected.
- Motors were replaced for pumps in RHRC and EECW.
- Temporary cable was laid to supply power from survived power cubicles in Rad-Waste Building and Unit 3 Heat Exchanger Building or mobile power vehicles.

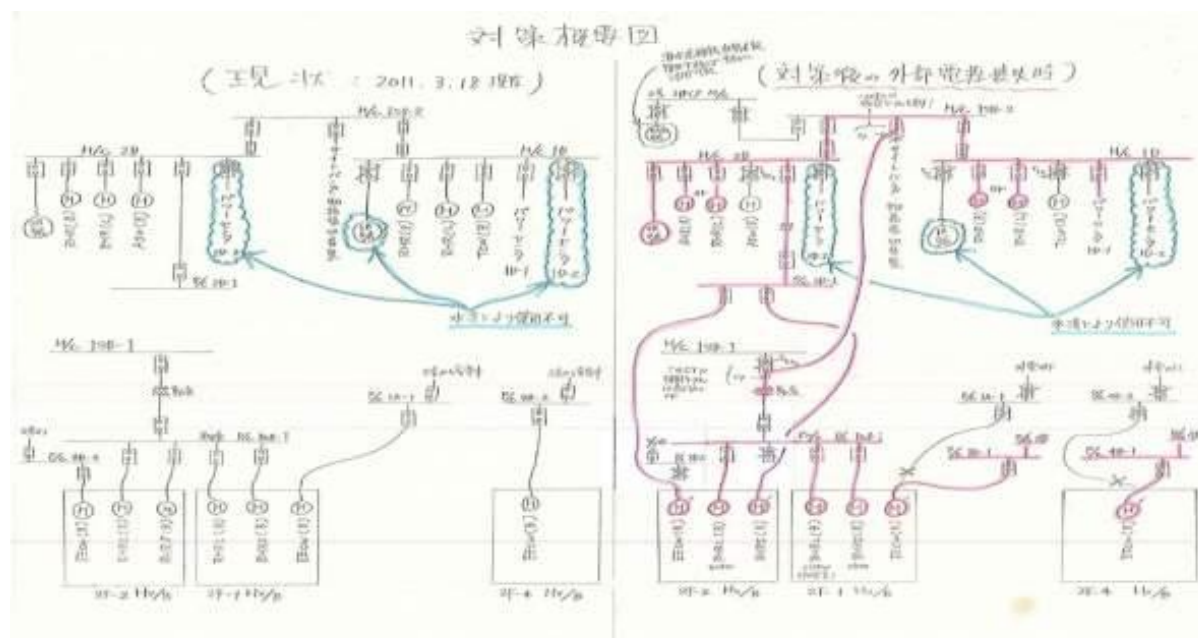
Drawing made at site ERC for temporary cable laying

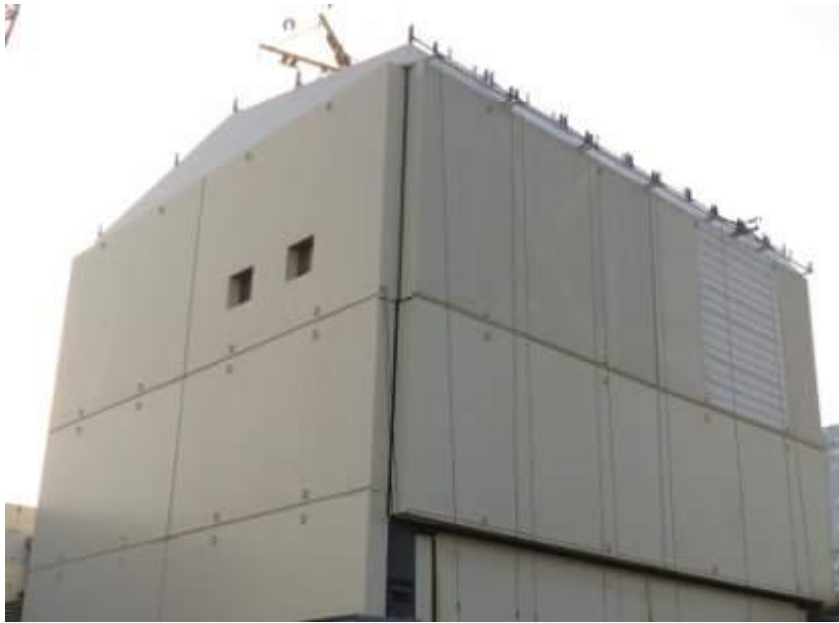
**Reactor building cover installed on 1F Unit 1**

- Agent sprayed to prevent dispersion of radioactive material.
- Reactor building cover installed on Unit 1.
- Removing rubble and storing/managing them according to radiation level.
- Primary Containment Vessel gas control system to maintain internal pressure of the PCV at around atmospheric level and to manage release.

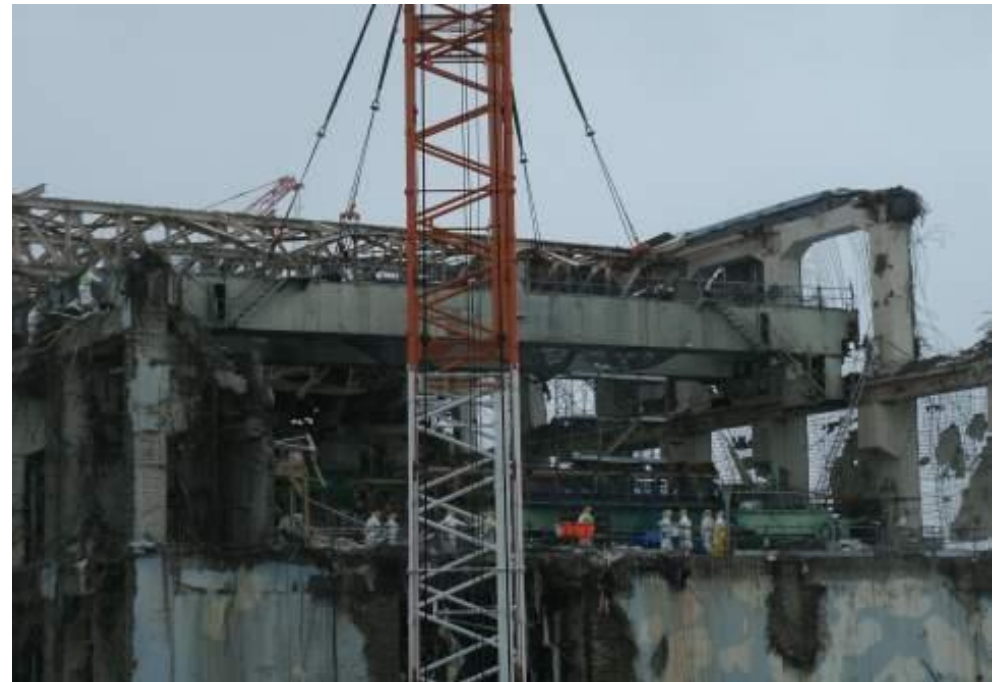
**Removing rubble from 1F Unit 4**
