# Main data on TNPP and on corrective actions taken after «Fukushima NPP» accident

**State integrated inspection of nuclear safety  
after «Fukushima NPP» accident**

# 1 State integrated inspection of nuclear safety after Fukushima NPP accident

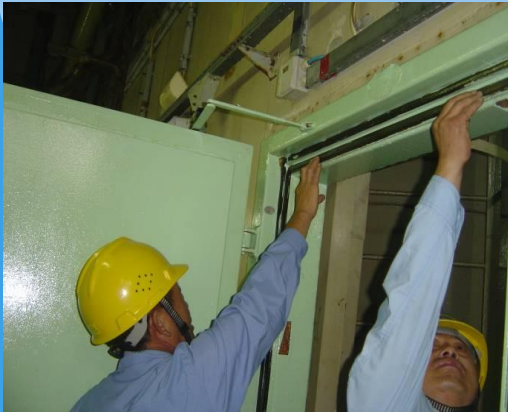
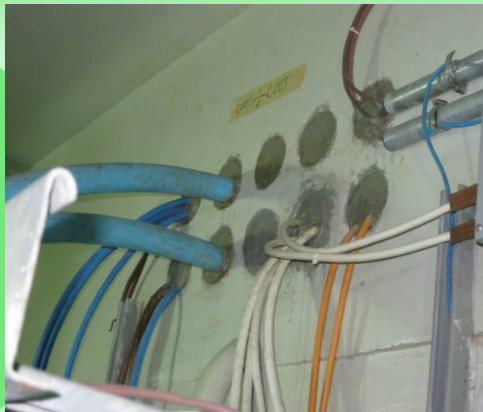
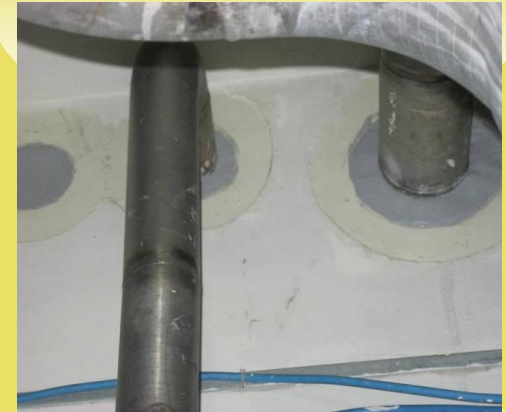
*“To check individually the water resistance of appropriate doors, windows, ventilation ducts, cable penetrations and penetration of process pipelines” . 2011-1*

Implemented corrective actions at TNPP.

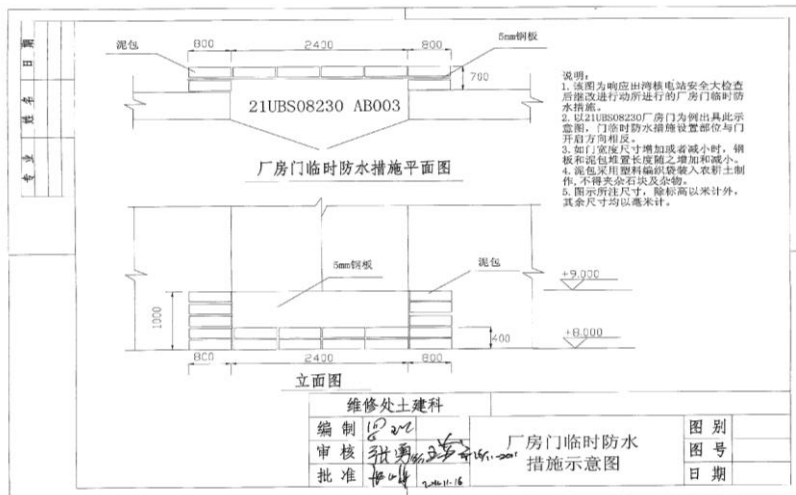
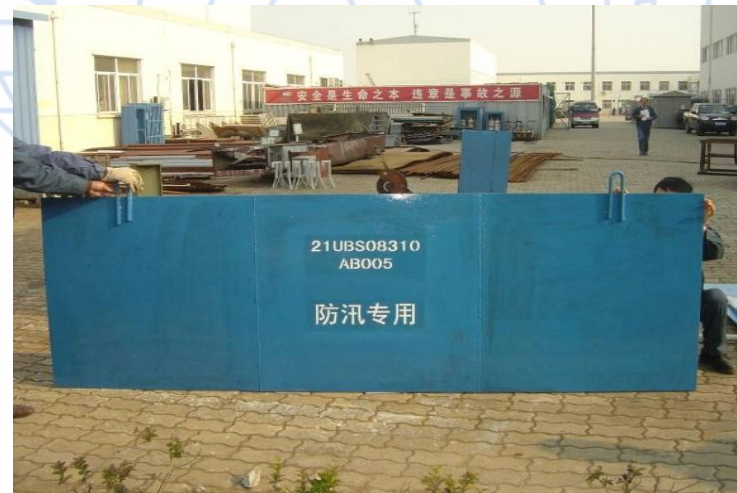
*Develop, prior to the completion of water protection wall on the inner side of east breakwater, and implement temporary measures to protect diesel generators, electrical building and other important construction from flooding.*

An emergency plan is developed against high water including activities to protect important buildings against flooding. Appropriate arrangements are prepared.
