# **Lessons Learnt from Fukushima Daini NPP (2F) and Status of Fukushima Daiichi NPP (1F)**

**June 4, 2012**

**Fukushima Daini NPP**

**TOKYO ELECTRIC POWER COMPANY**

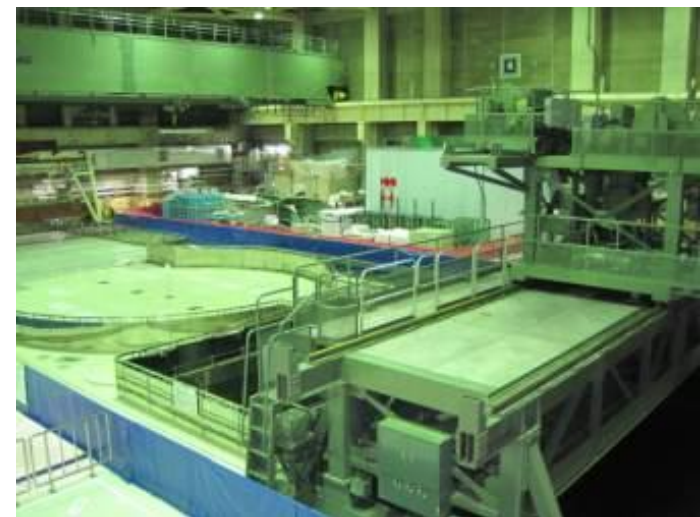
Reactor refueling floor

- All units automatically tripped\* by acceleration signals.
- Seismic acceleration spectra were mostly within the design values.
- No damage to safety related SSCs was caused by seismic impact.

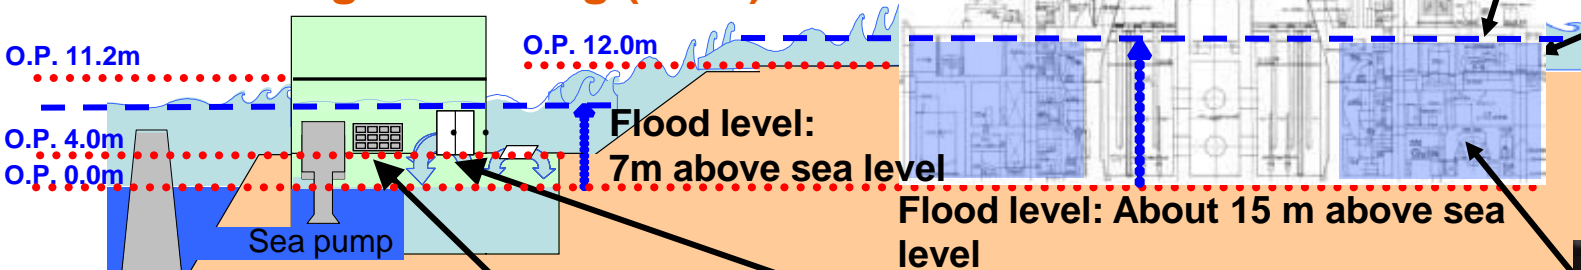
- R/B: Flooding through ventilation louvers  
→ Damage in emergency power system
- Hx/B: Damage of watertight hatches  
→ Damage in reactor cooling system

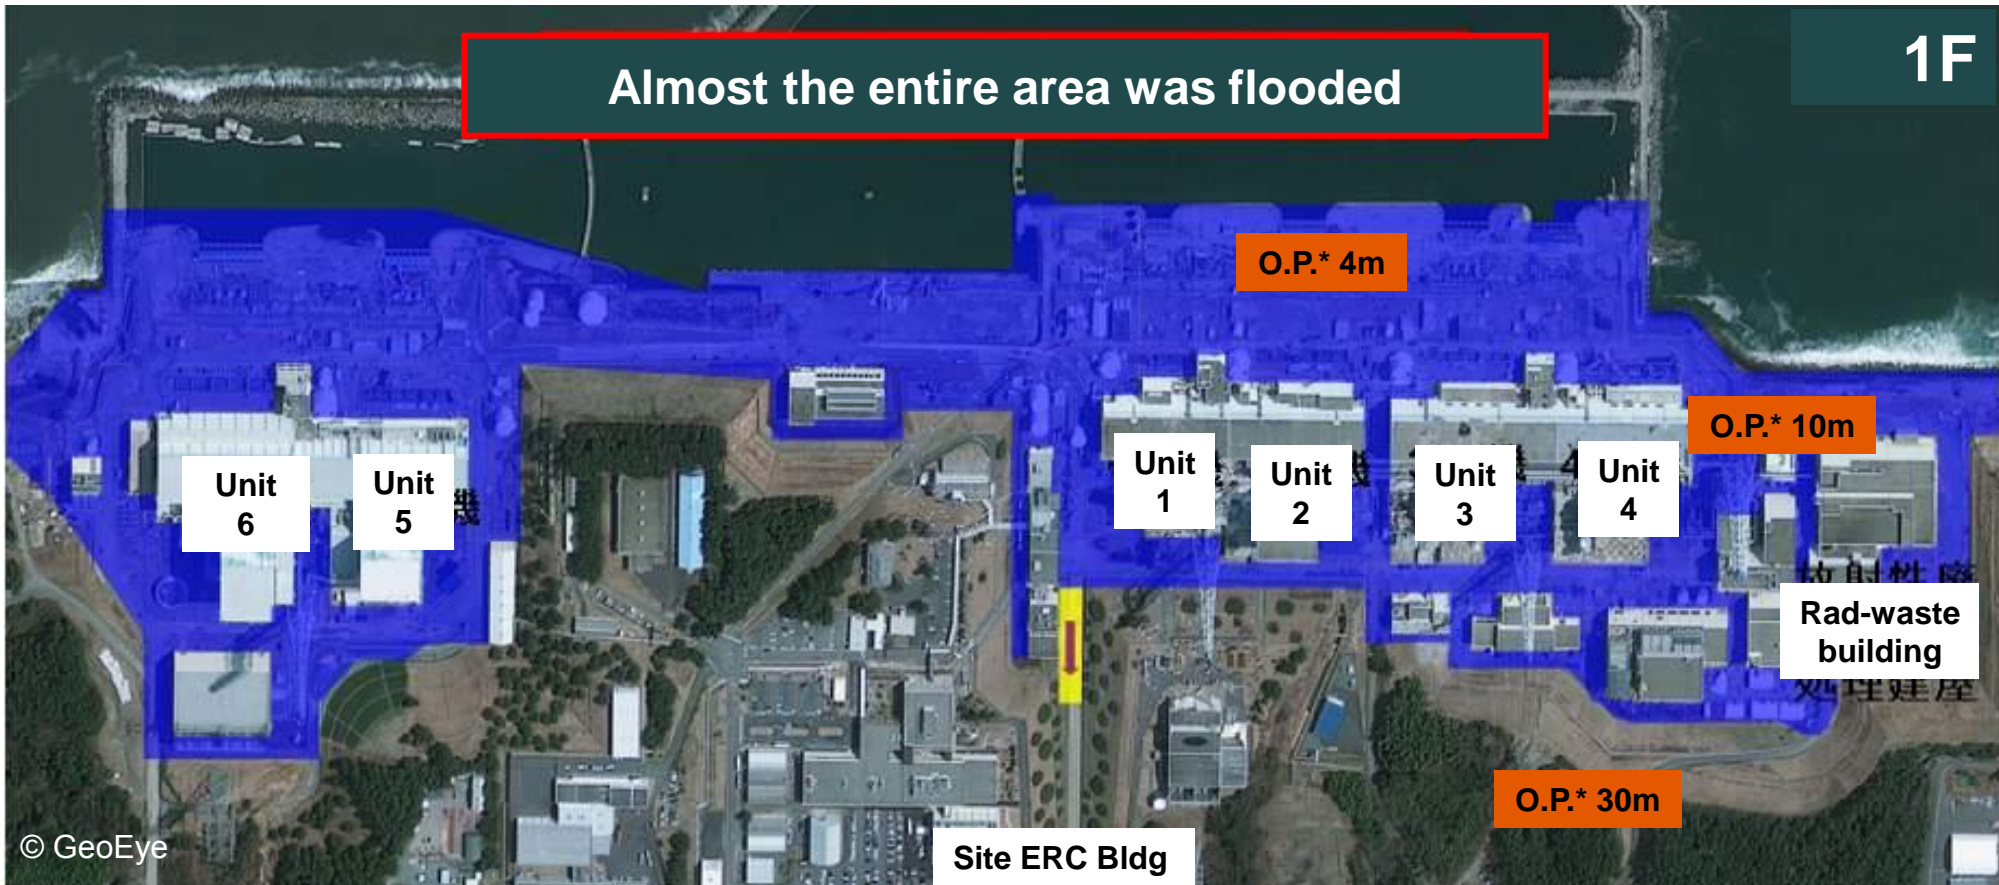
- Observed seismic acceleration exceeded design response at only limited locations.
  - No damage to safety-related equipment due to the earthquake confirmed to date.
- Tsunami severely flooded most of the major buildings.
  - Estimated tsunami height of approx. 13 m (43 ft) was much greater than the design basis of 6.1 m (20 ft).

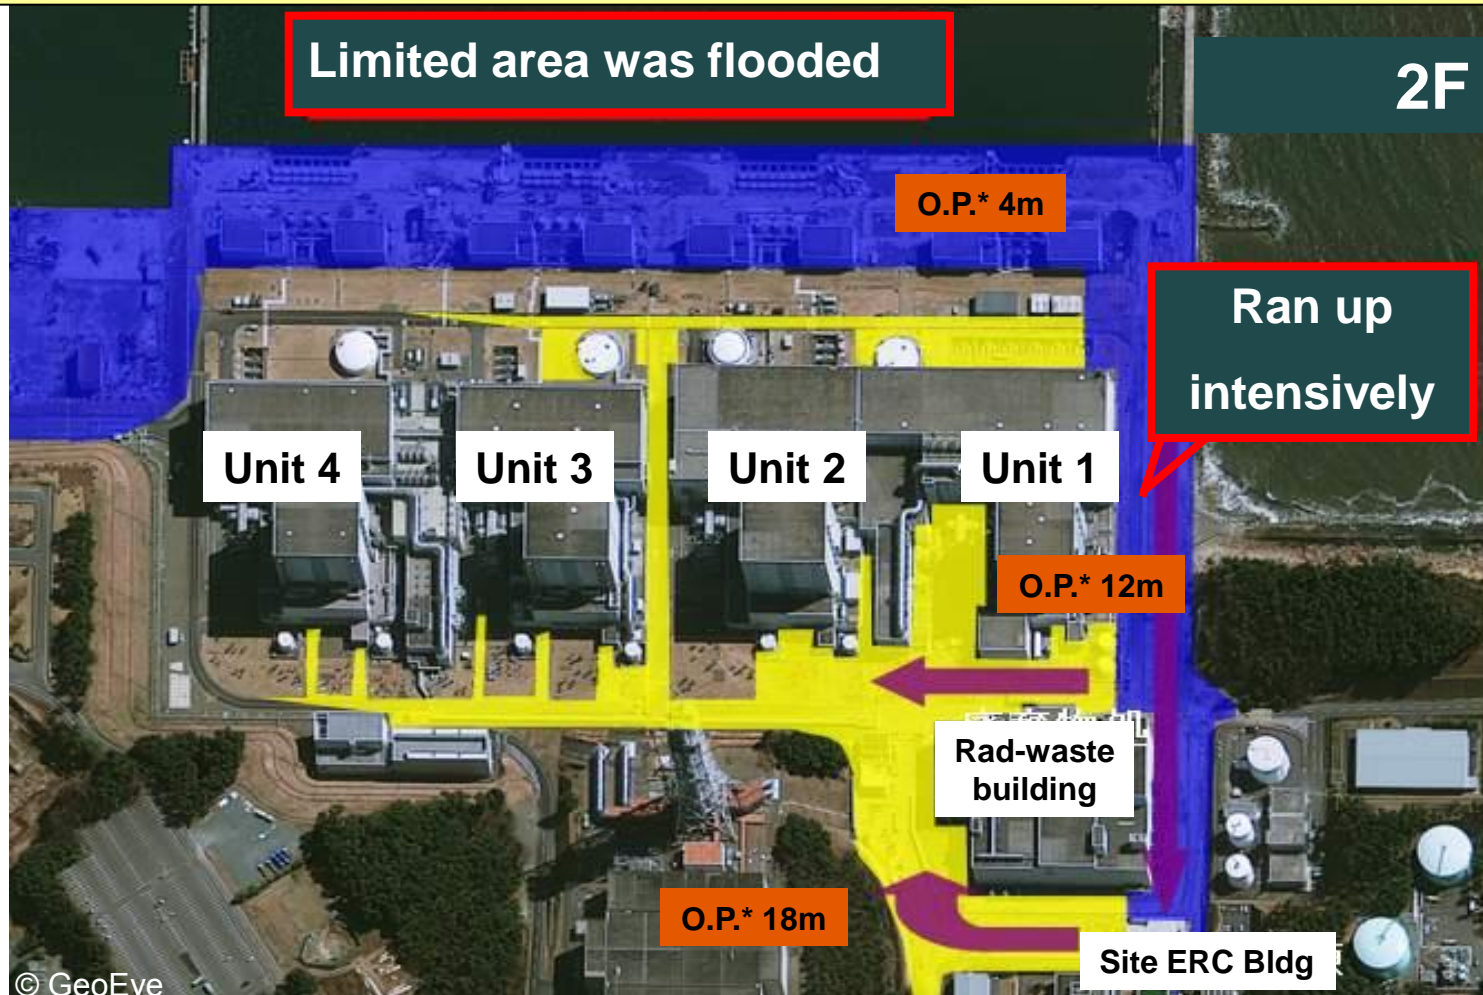
- Observed seismic acceleration was mostly smaller than design response.
- Damage due to tsunami was less extreme compared to 1F.
  - Estimated tsunami height of approx. 9 m was much greater than the design basis of 5.2 m.
